ONLINE PUBLIC OPEN HOUSE

SCHEDULE "B" MUNICIPAL CLASS
ENVIRONMENTAL ASSESSMENT
WOOLER ROAD CNR/CPR OVERPASS

April 21, 2023

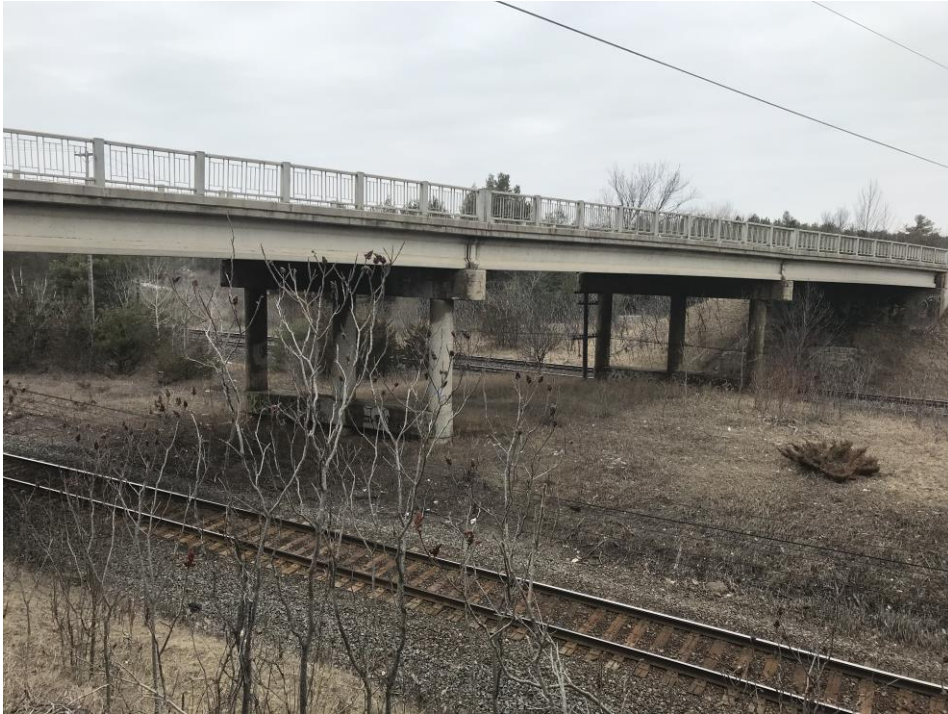
PROJECT STUDY AREA

The Wooler Road CNR/CPR Overpass is located in the formal municipality of Murray within the City of Quinte West. The bridge crosses over both the Canadian National Railway (CNR) and the Canadian Pacific Railway (CPR) at approximately 2.3 km south of Highway 401 and 950 m north of Highway 2.

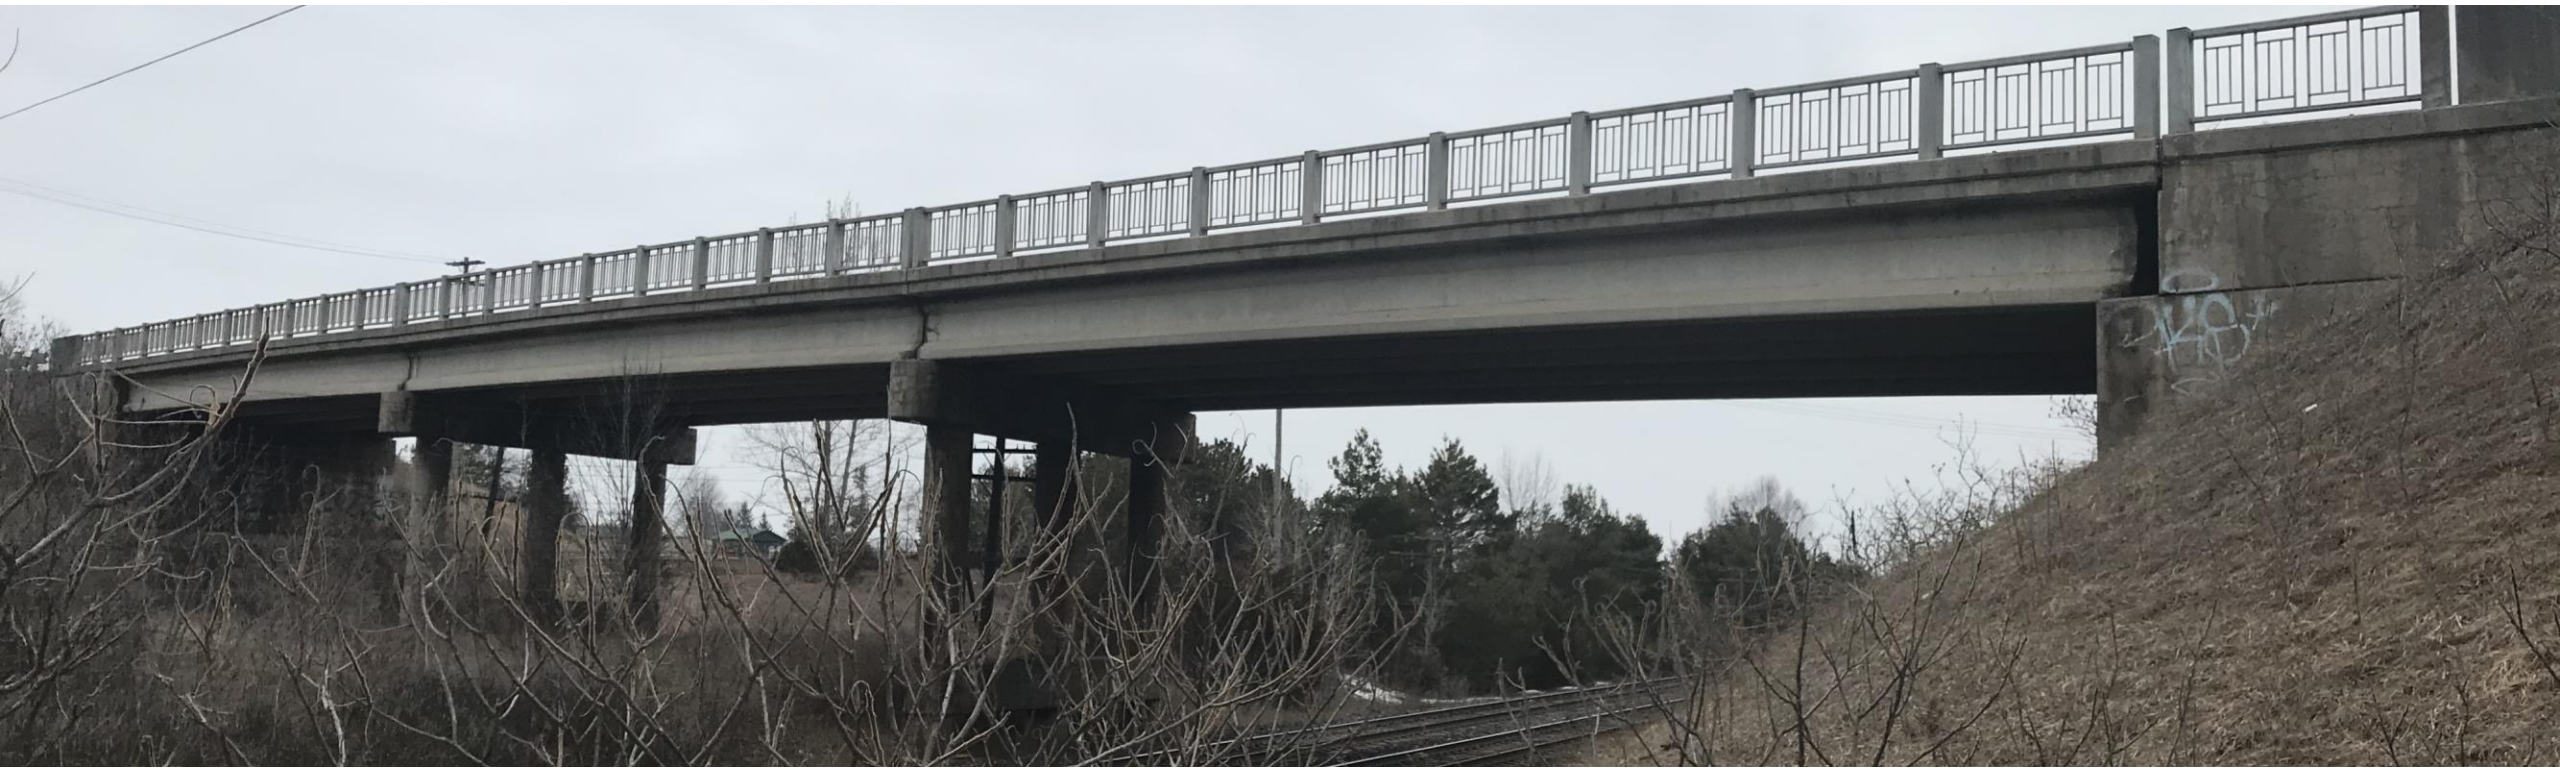
The Wooler Road CNR/CPR Overpass is in a state of deterioration and requires rehabilitation or replacement. The existing bridge is currently carrying two lanes, with no ability to widen to four lanes, and no capacity for active transportation facilities. Therefore, the City of Quinte West has the opportunity to identify and evaluate alternative solutions and determine a preferred bridge solution in accordance with the MCEA Process.

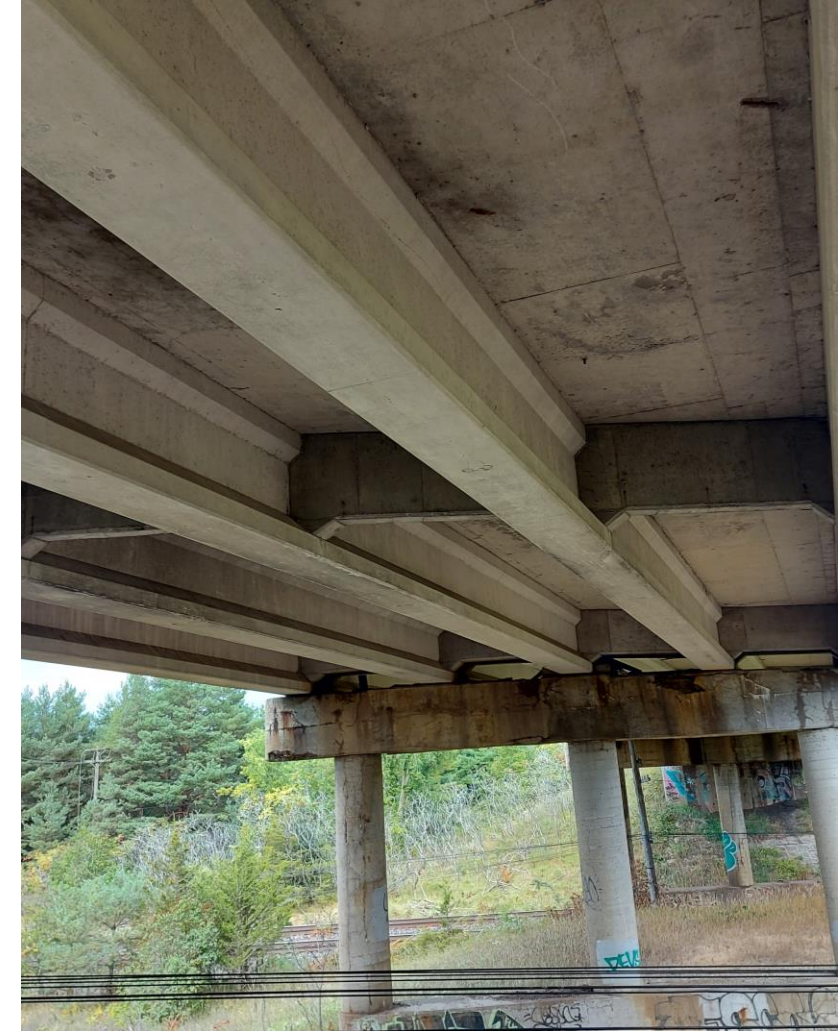
To ensure a consistent comparison among the rehabilitation alternatives, a like-for-like full structure replacement with new NU precast girders was considered.

The Technically Preferred Alternative Solution to the Problem/Opportunity Statement is Alternative 5 – Like-for-like Full Structure Replacement of the Wooler Road CNR/CPR Overpass in the current location.

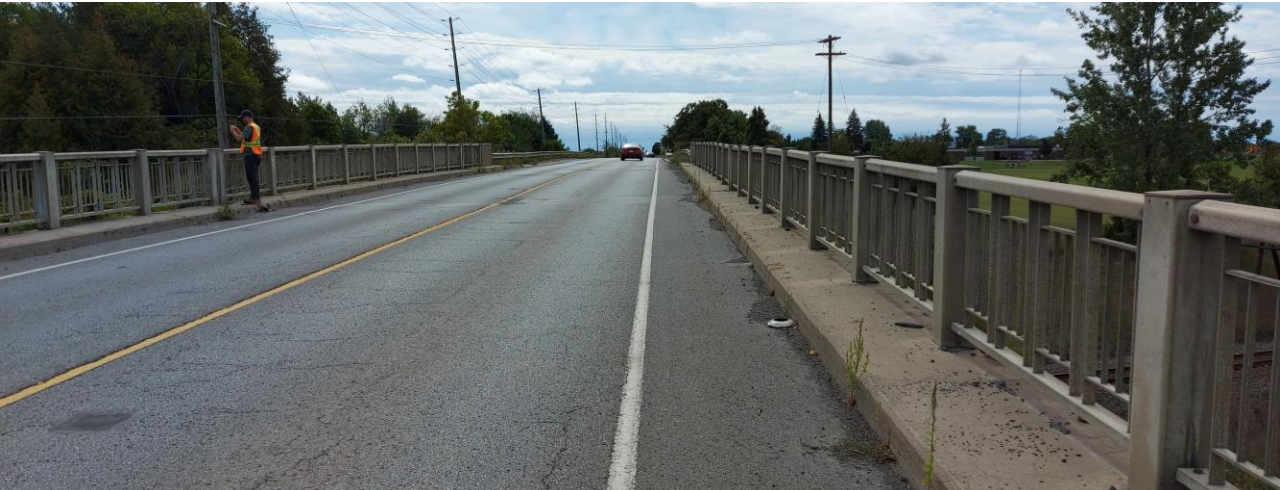
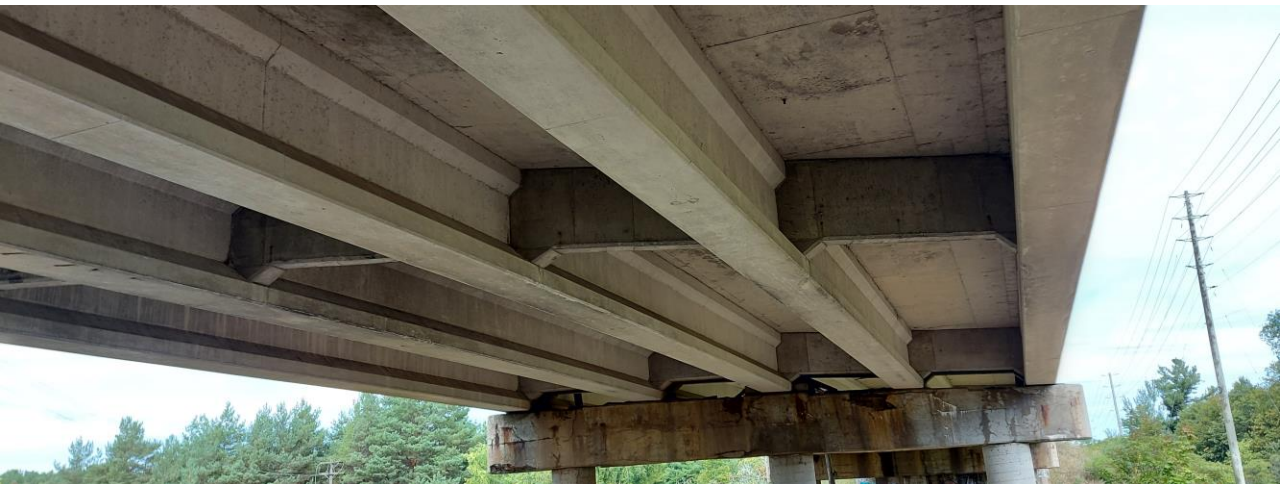
EXISTING STRUCTURAL CONDITION

Structural Condition

- The existing structure was constructed in 1970
- Three equal span (22.067 m) simply supported concrete slab (178 mm thick) on AASHTO Type III precast prestressed concrete girder bridge, with a total span of 66.2 m.

- The structure has an overall width of 11.07 m and the roadway width between concrete curbs is 9.14 m. The bridge carries two 4.57 m wide lanes and 0.9 m concrete safety curbs with a steel railing system.

- The bridge is supported on reinforced concrete abutments and piers. The abutment is founded on steel H-piles and the piers are supported on spread footings.

- In 2006, Wooler Road was resurfaced, including asphalt paving over the expansion joints at the bridge abutment and pier joints. Otherwise, it does not appear that the structure has undergone any major structural rehabilitations.

- The Detailed Bridge Condition Survey Report (2020) Ontario Structural Inspection Manual (OSIM) inspection in 2019 determined that the bridge is in generally fair to poor condition and requires rehabilitation and/or replacement.

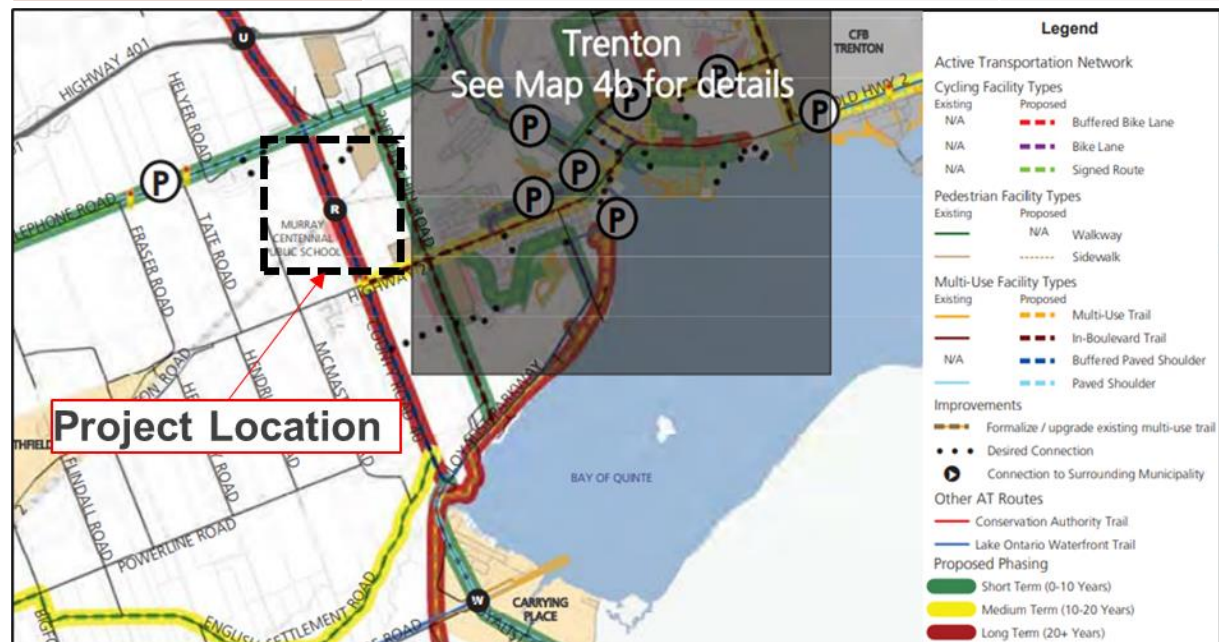
EXISTING TRAFFIC CONDITIONS

Year	Average Daily Traffic Forecasts	Level of Service
2021	10800	-
2023	11170	C
2028	12100	C
2033	13030	C
2043	14890	D

Existing Traffic and Operations

- Wooler Road, County Road 40, has a two-lane rural cross section and a posted speed limit of 80 km/h.
- Annual Daily Traffic data and projections were obtained through historical traffic data provided by the City, and data collected in summer 2021.

- Data showed 1.72% of annual traffic growth on Wooler Road.
- Data showed that 7% of the traffic on Wooler Road is made up of trucks and heavy vehicles.

- Operational analysis indicate that the existing Wooler Road corridor will continue to adequately serve future traffic forecasts beyond the 20+ year time frame.
