File Report for the Northwest Trenton Water Capacity EA

January 18th, 2023

City of Quinte West,
7 Creswell Drive, PO Box 490,
Trenton, ON
K8V 5R6

Project No.: 22-3-7761

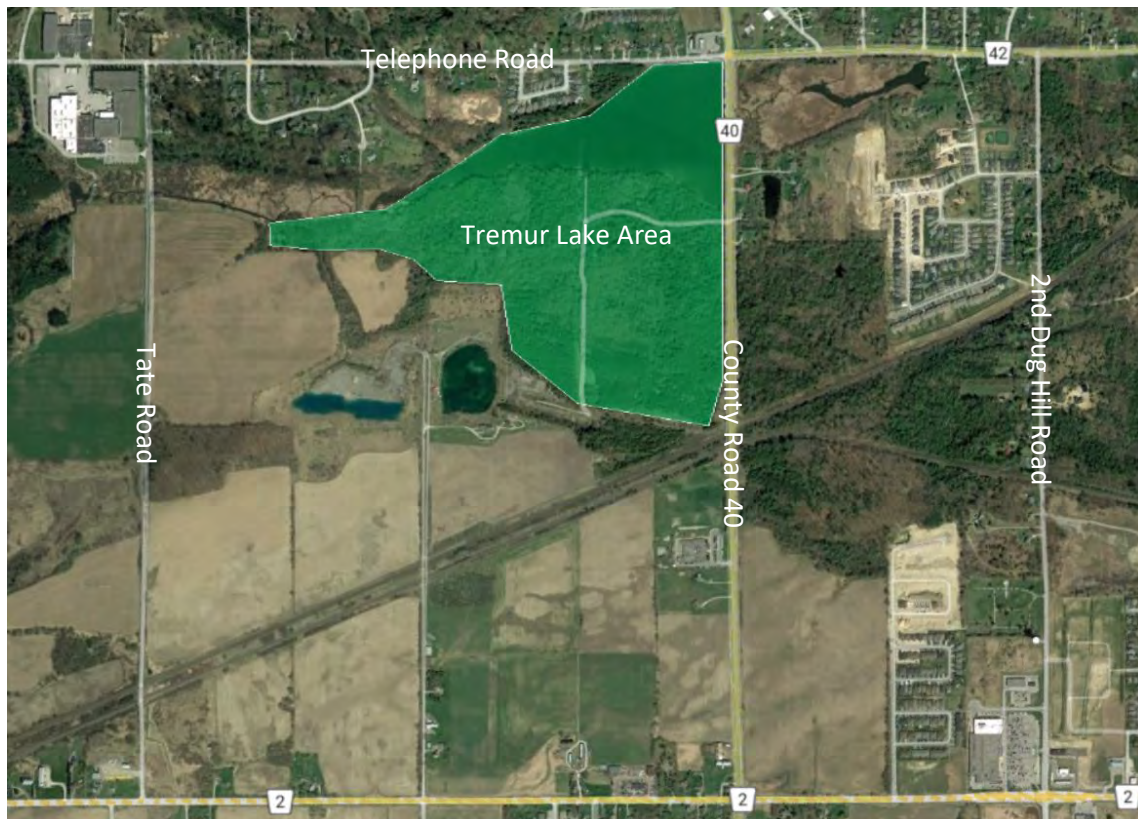
Figure 1: Aerial view of Northwest Trenton

The relevant area of study is dependent on the alternative solution considered, however, in general this EA considers solutions within the area West of 2nd Dug Hill Road in Trenton, to Tate Road, and North of Highway 2, to Telephone Road. The area consists mostly of municipal roadways and farmland however the area most relevant to this ESR from an environmental and heritage standpoint is the Tremur Lake property located between County Road 40 and Tate Road which has several wetland areas and water sources.

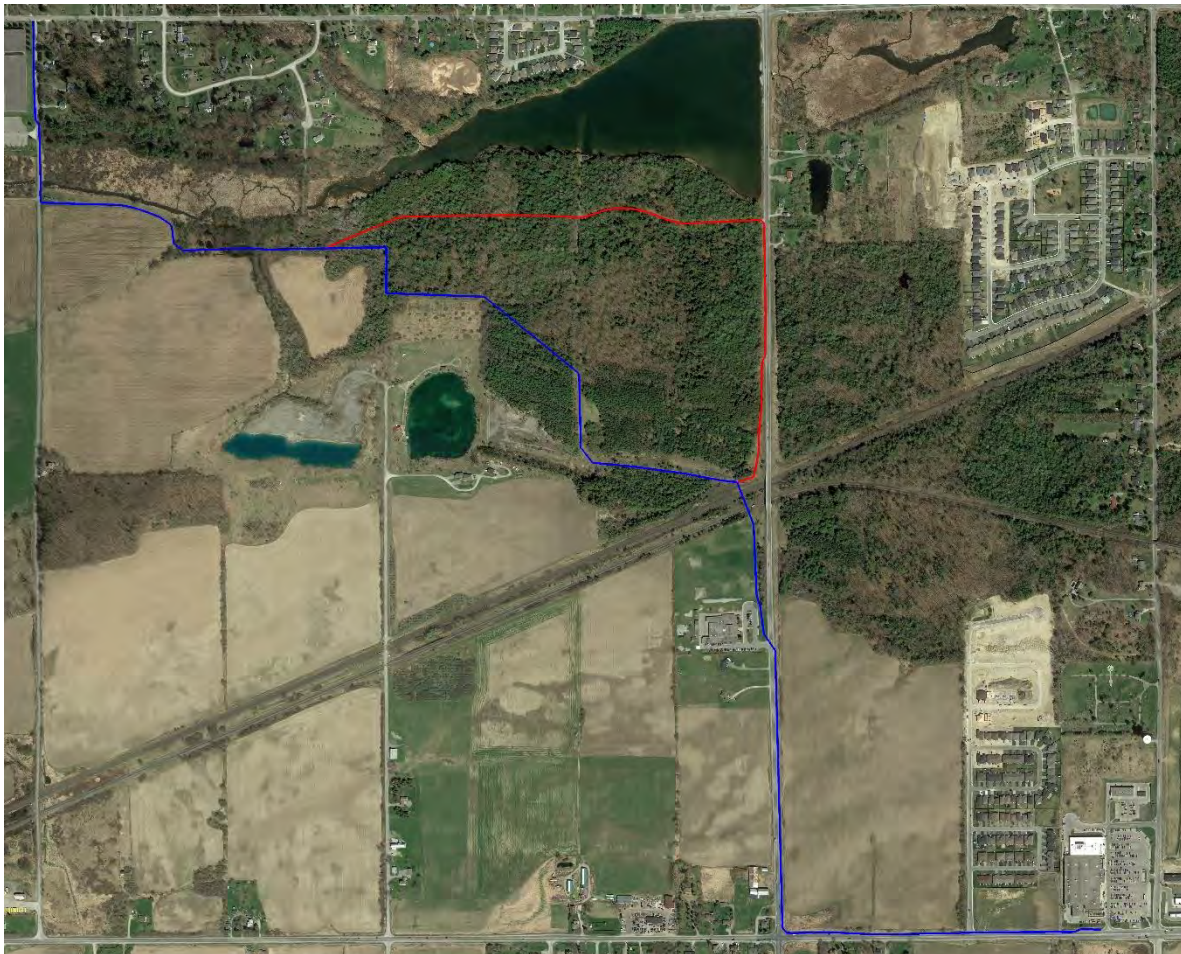
Figure 4 - Alteration to Route

Following the identification of these environmental factors, routing was revisited, and a possible alternative route was found. The alternative route would avoid the wetland areas by moving the watermain further south around the Tremur Lake property, utilising an existing access route, and non-wetland undeveloped land. This route also increases the distance between Tremur Lake and the watermain. The initial route was selected as the alternate route requires an additional easement through private land. The additional easement was found to be feasible in talks with the private landowner, therefore this route was adopted. The EIS and Stage 2 Archeological report include this route. In the image below, the red route was the original intended routeing through the Tremur Lake property, and the blue is the newly proposed routeing.

was found that it was not feasible to install the watermain along the Tremur Lake dam, under the road allowance, so alternate routes had to be considered around Tremur Lake. Initially a route was considered that would pass through the undeveloped land south of Tremur Lake. The municipality owns most of the land relevant to that route with the exclusion of one easement through privately owned land that would be required. Through the environmental impact study (available in Appendix A), it was found that the undeveloped land to the south of Tremur Lake contains significant portions of wetland and the possible presence of Blanding's Turtle habitats. This route would also require the clearing of tree through the route that would need to be sequenced to mitigate possible negative affects to bird and bat populations.

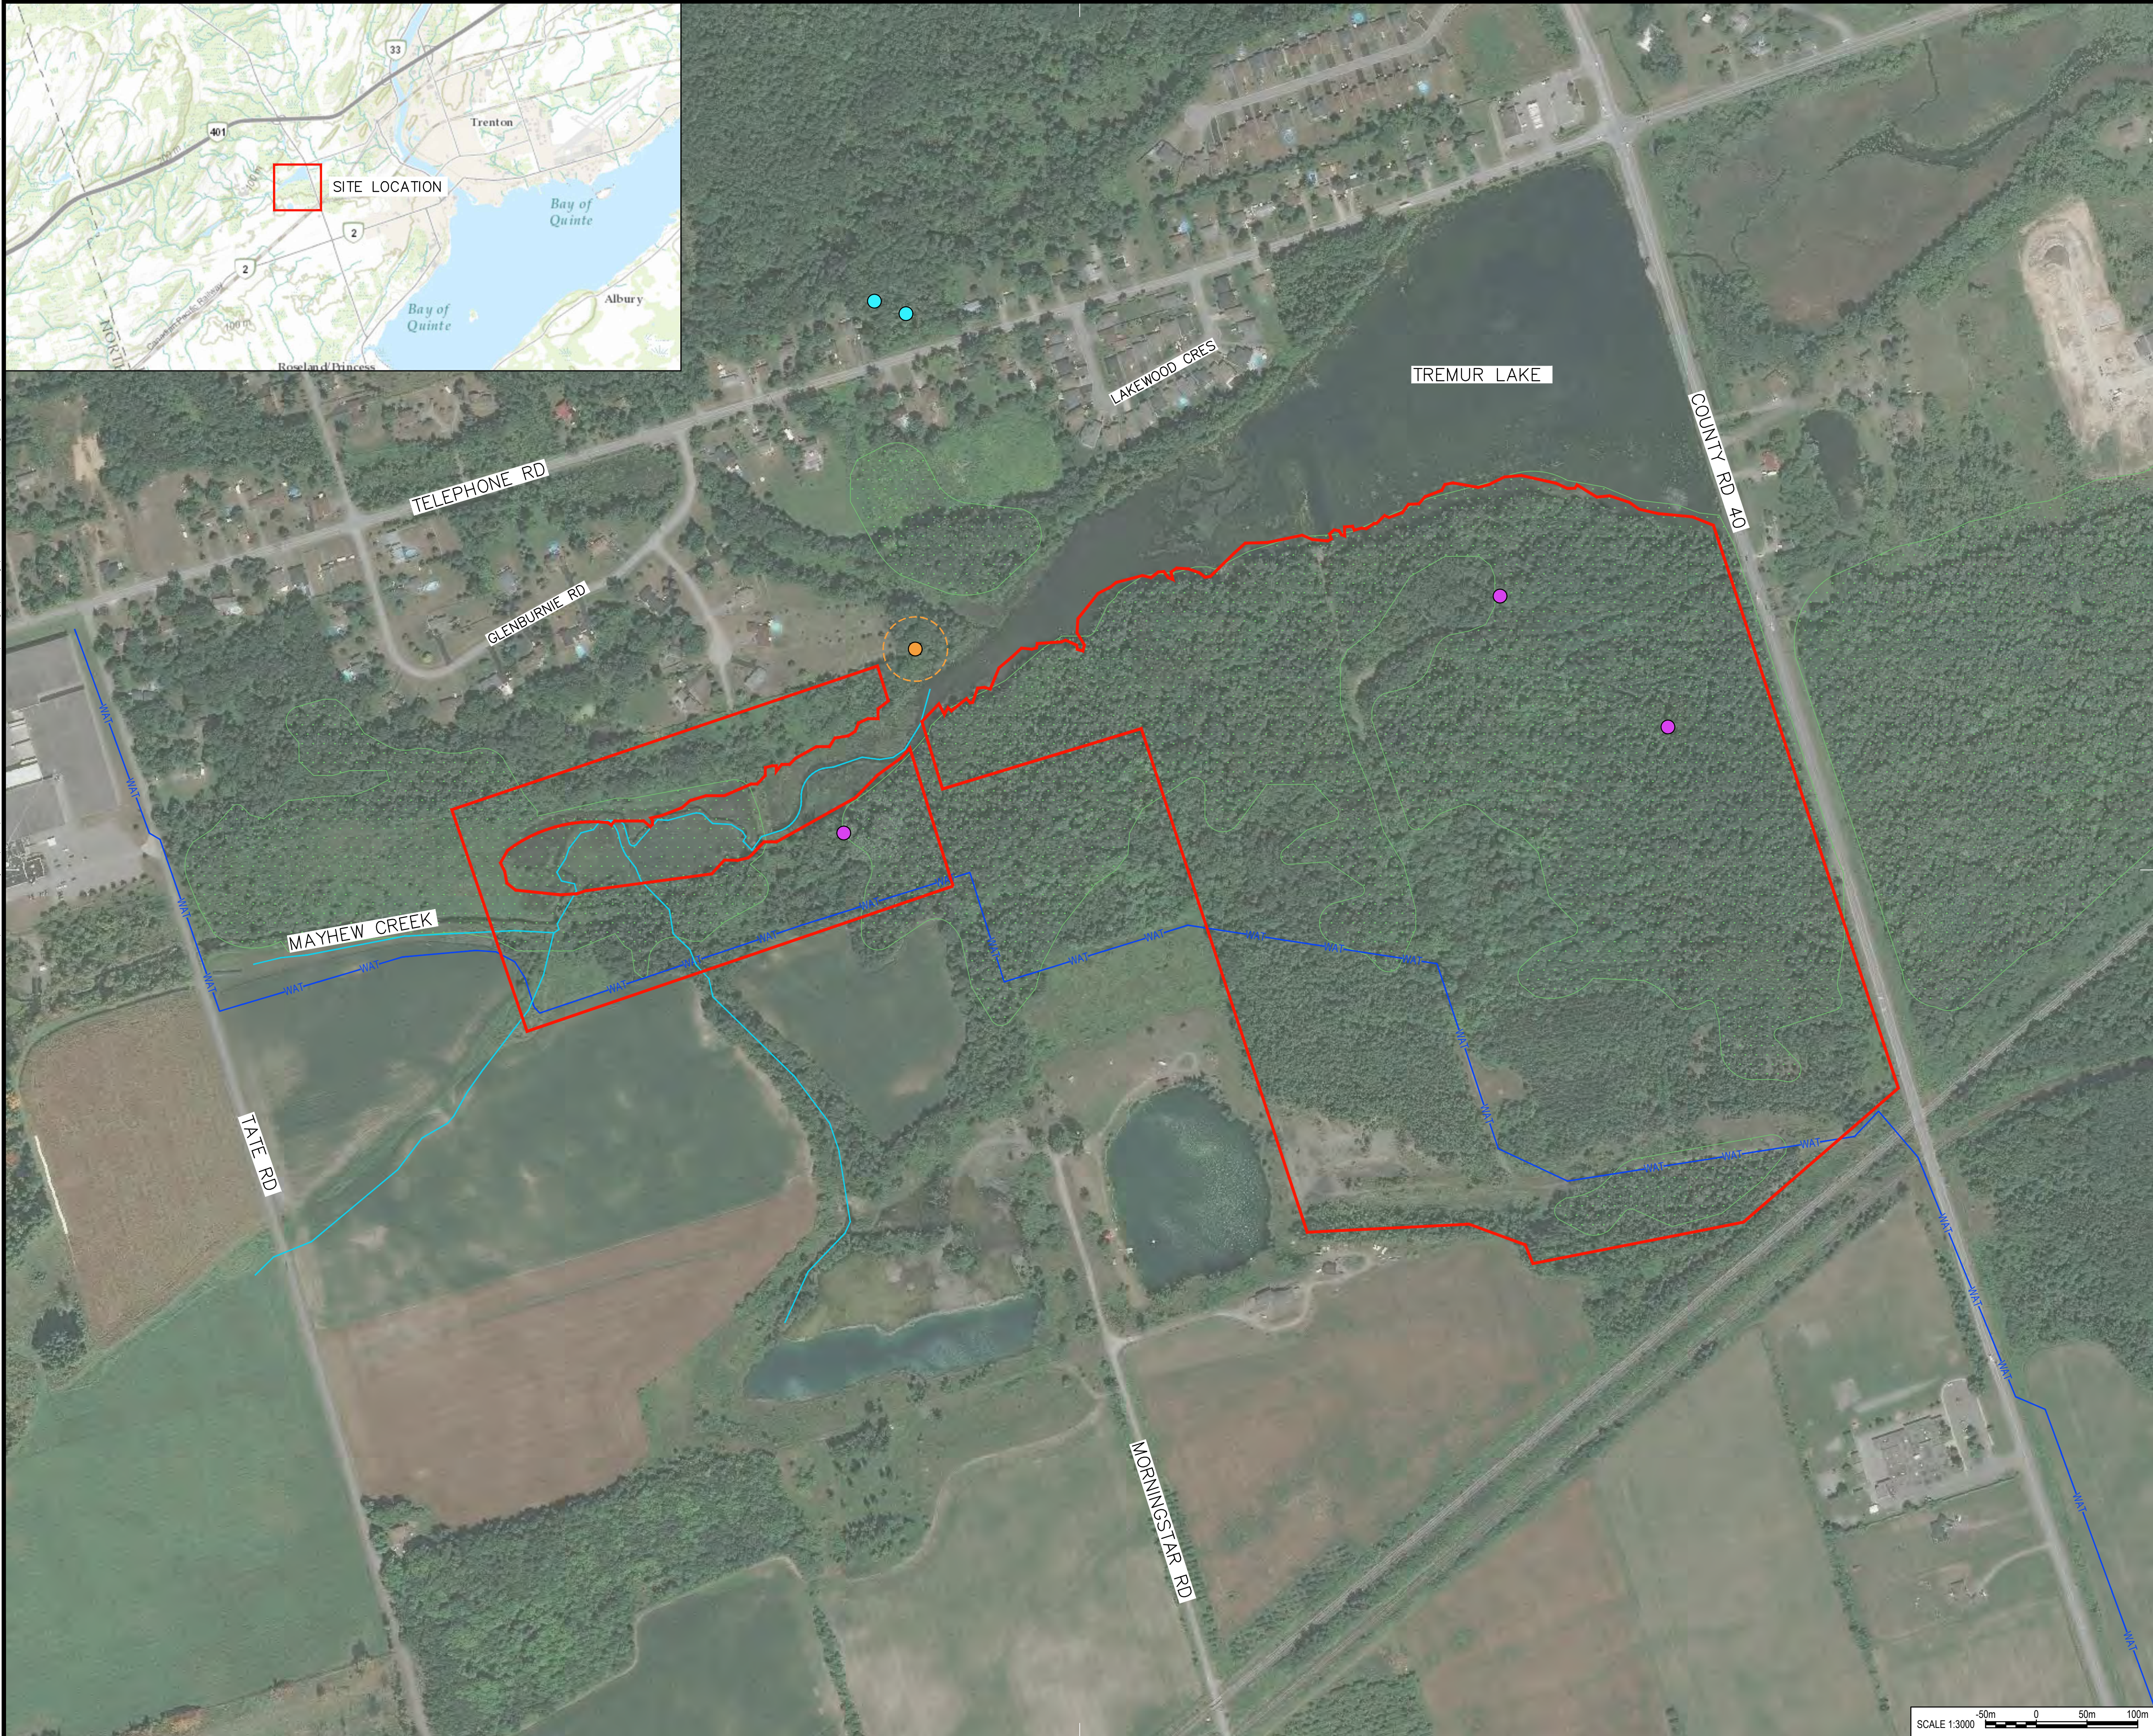
DRAWING #
FIGURE 4

Wood Thrush was heard in the forest, in three locations. Figure 4 shows the locations where Wood Thrush was heard. The site investigations were performed outside the nesting season, but the nesting habitat is present. Impacts to Wood Thrush are not expected as the area required for the watermain is minimal and vegetation will be removed outside the nesting season. Mitigation measures should be applied to avoid harm to Wood Thrush.

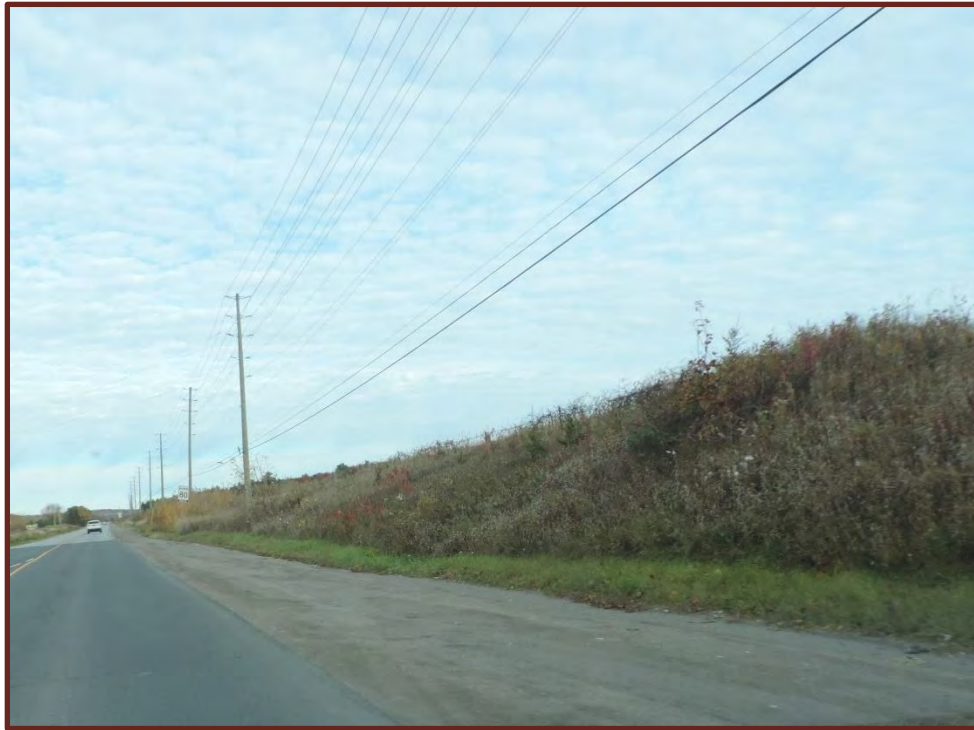
Photo 11. Looking north the east side of County Road 40 where the watermain will be located.

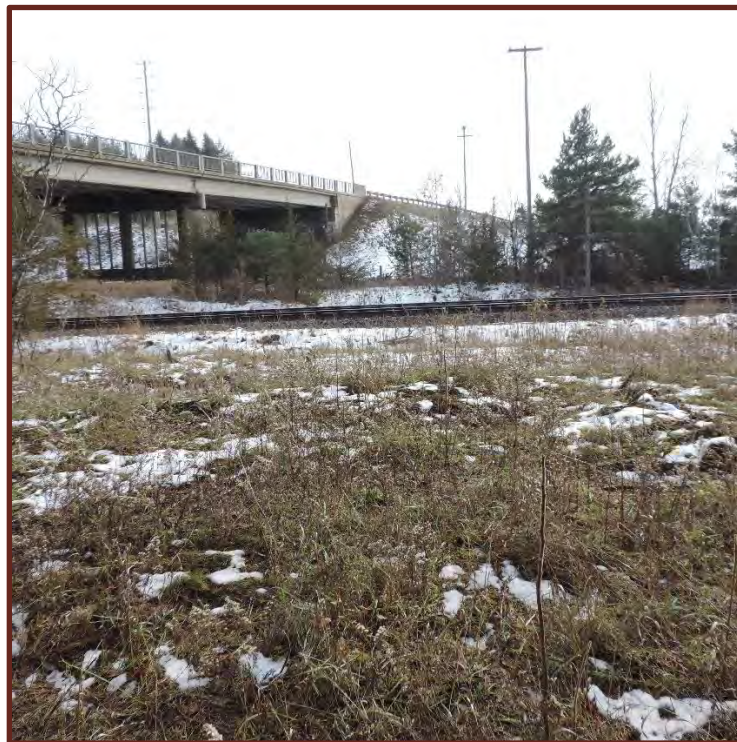
Photo 12. Looking south the area where the waterman will cross the train rails.

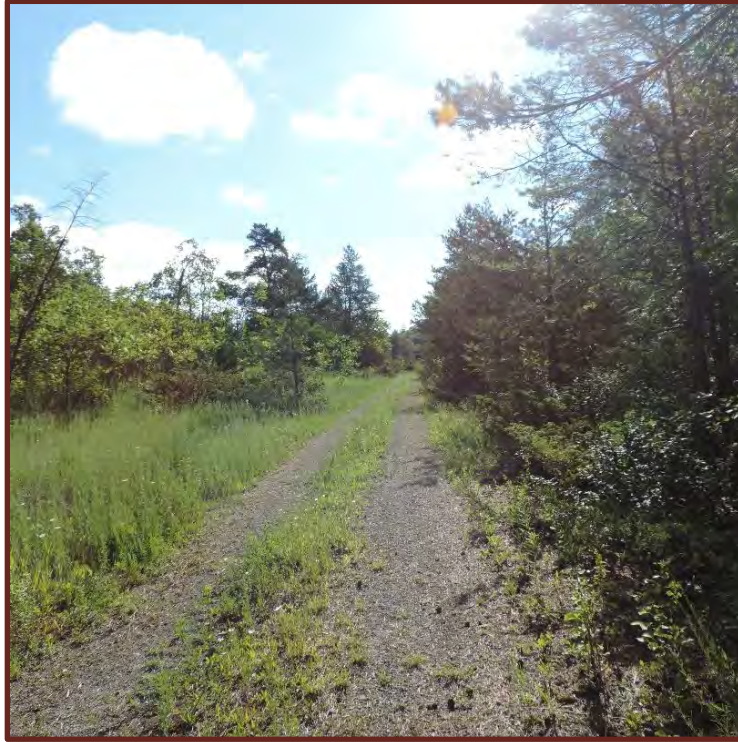
Photo 13. Looking east the trail/road southern part of the land owned by the City where the watermain will be installed.

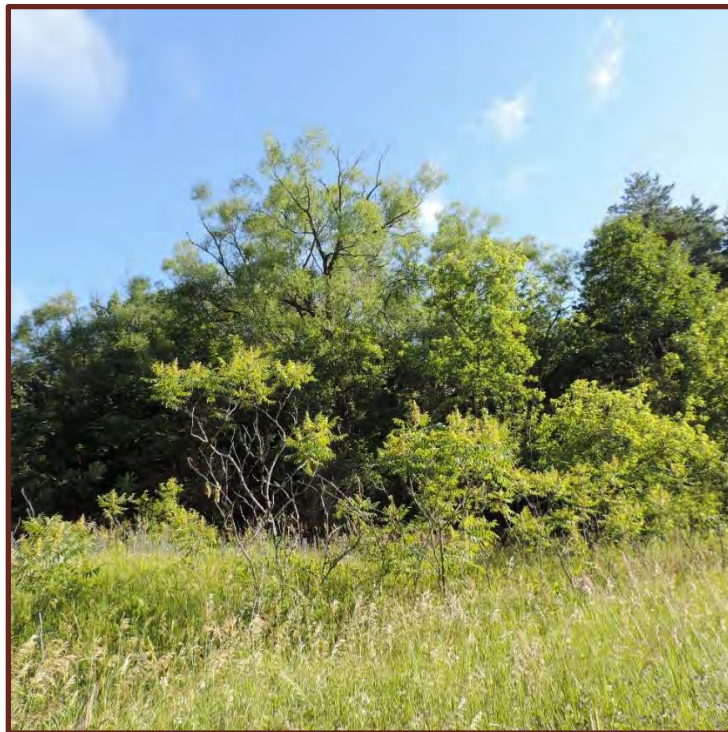
Photo 14. Cultural woodland and meadow vegetation to be affected by the installation of the watermain.

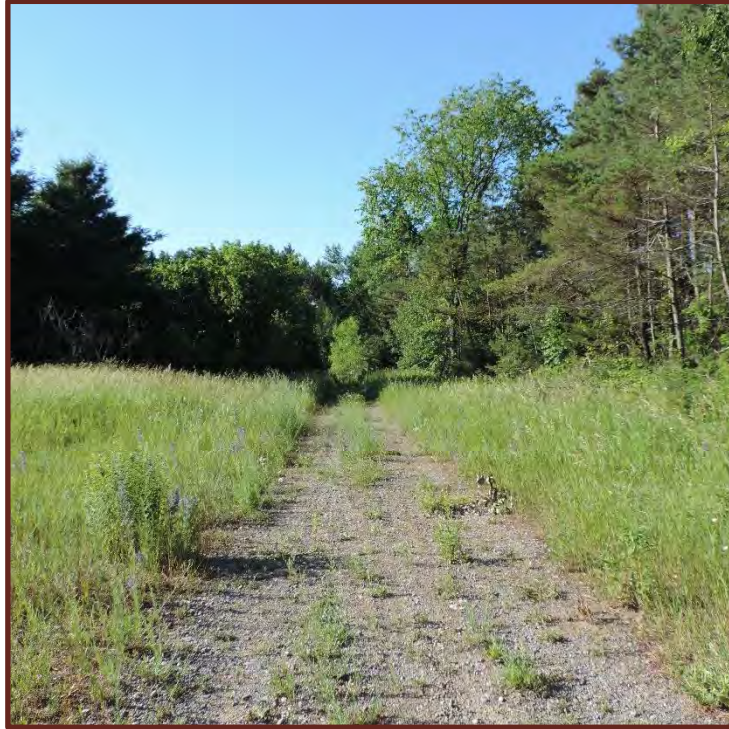
Phot 15. View of a portion of the trail/road that runs in south to north direction where the watermain will be installed.

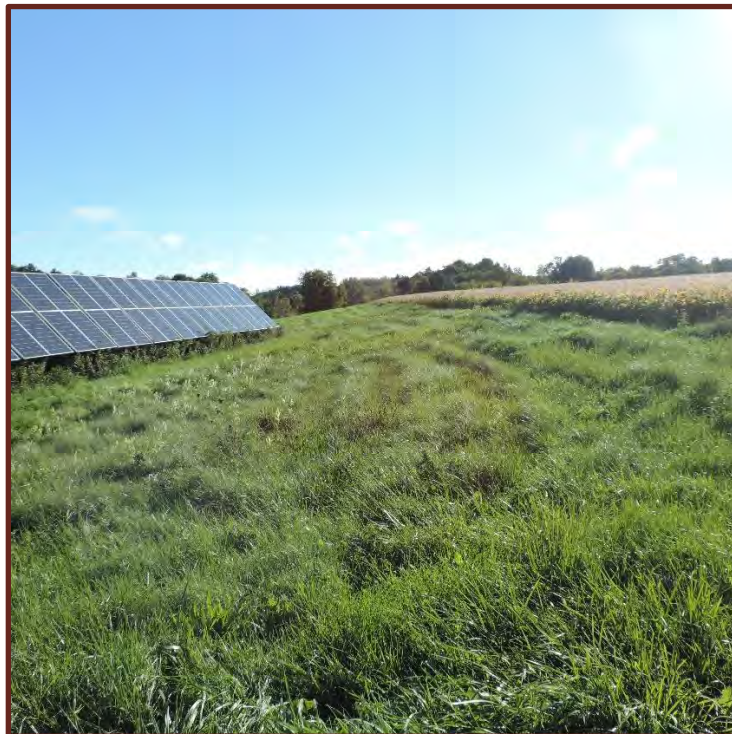
Photo 16. Looking east the agricultural land where the watermain will be installed prior to reach Tate Road.

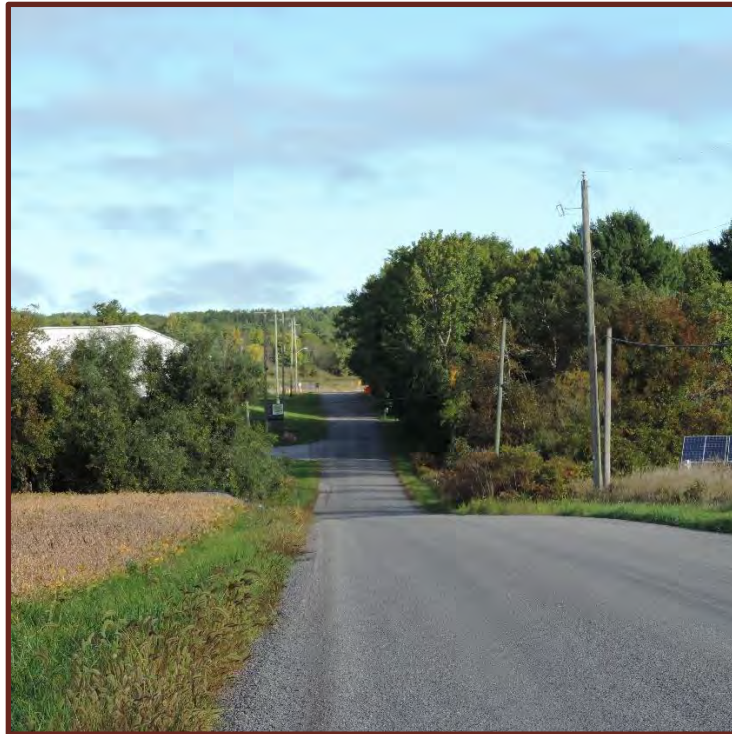
Photo 17. Looking north Tate Road where the final section of the watermain will be installed.

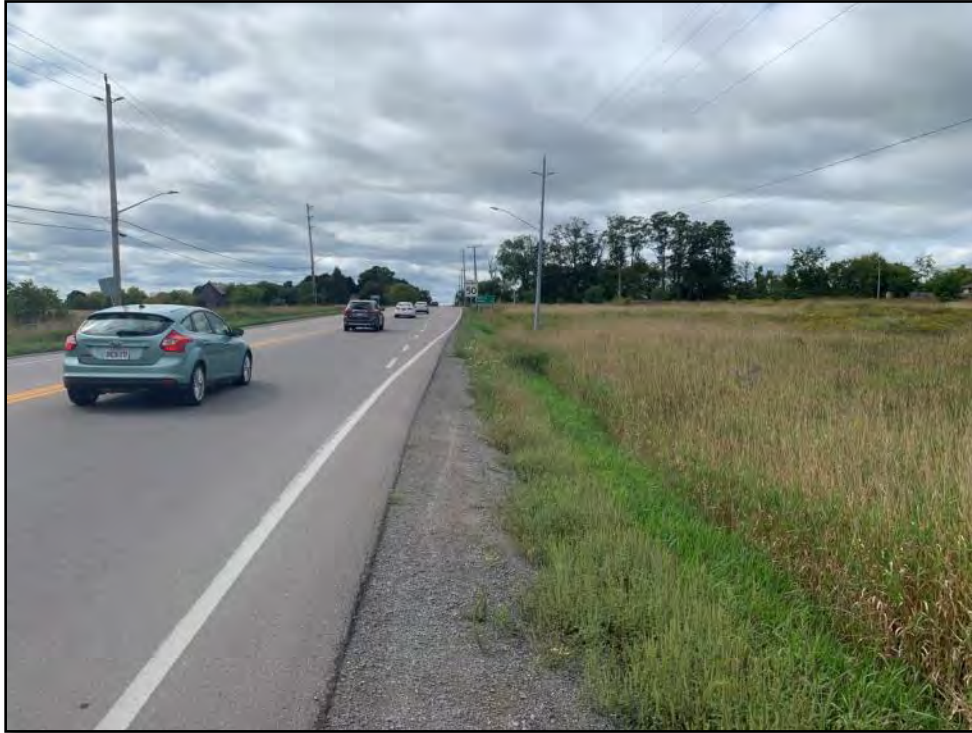
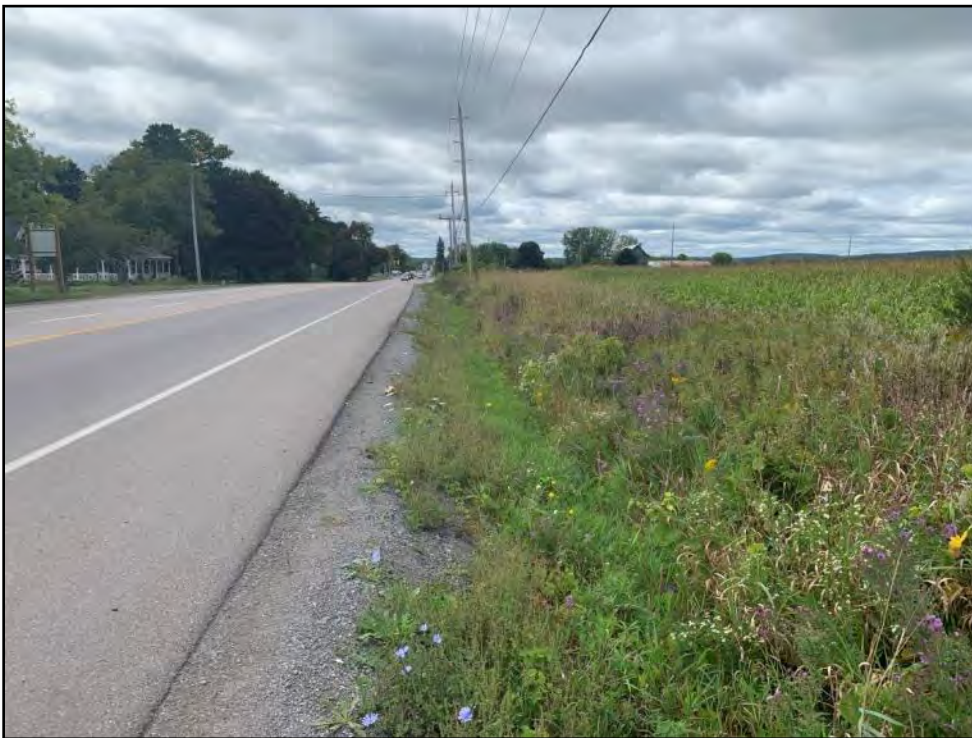
Image 1. A view west along the north frontage of Highway 2.

Image 2. A view west along the north frontage of Highway 2.

The property inspection found that the roadside areas of the subject property contain deep mechanical disturbance. The watermain route along the north frontage of Highway 2 contains a raised roadbed area and deep ditching between the road surface and the privately owned fields to the north (Image 1, 2). The impact of modern mechanical construction, repair and upkeep of the roadways has removed potential in these areas. The eastern frontage of County Road 40 was found to contain large berms (Image 3) and additional ditching (Image 4). At the location south of the CN railway overpass the subject property contains a large fill deposit which was created to support the roadway overpass of the railway line (Image 5). Additional disturbance was created by the construction of a nearby school structure along the County Road 40 road frontage. At the northern end of the overpass a gravel roadway providing access to the railway was created.

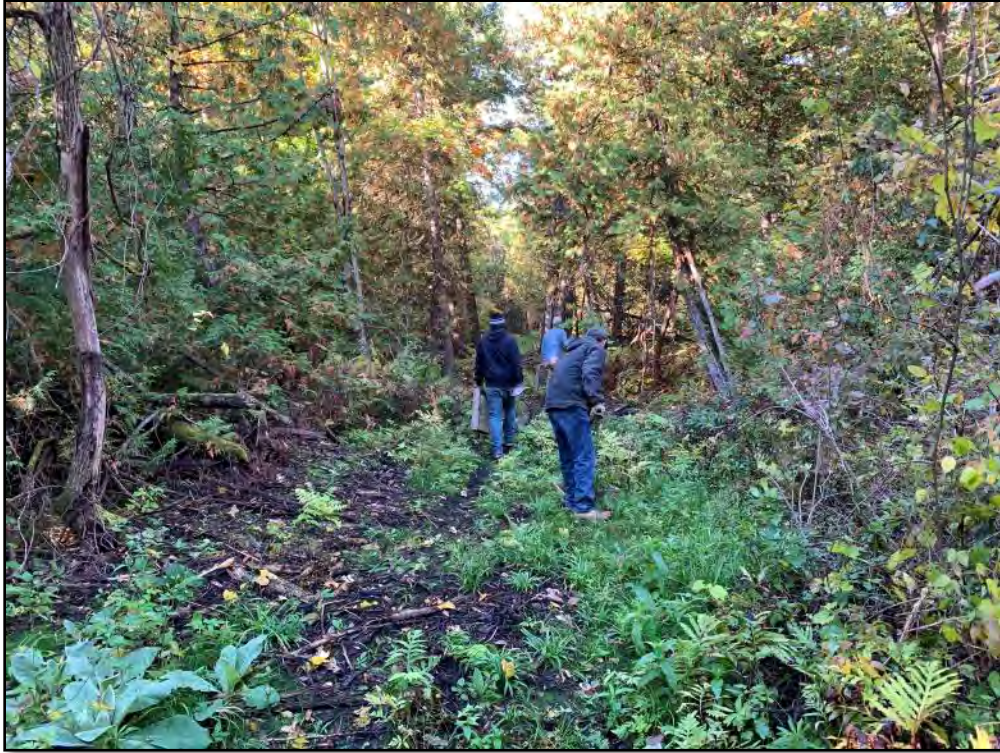
Image 9. A view east along the south shore area of Tremur Lake towards County Road 40.

The property contained mostly thin clay based soils. Testing along the eastern extents of the high potential area found primarily disturbed gravel roadway fills associated with the established lane (Image 9). Within the undisturbed wooded areas dense silty clay topsoil was commonly found over the subsoil clay or in some locations directly over the bedrock. A consistent soil profile was encountered with a dark greyish brown silty clay topsoil (20% silt, 80% clay) found over top of mid greyish brown clay subsoil or bedrock. The test pits in the property were excavated to an average depth of 25-30 cm. The western limits of the Stage 2 study area found looser clay loam soils within an area located adjacent to the stream and bounded to the south by an agricultural field.

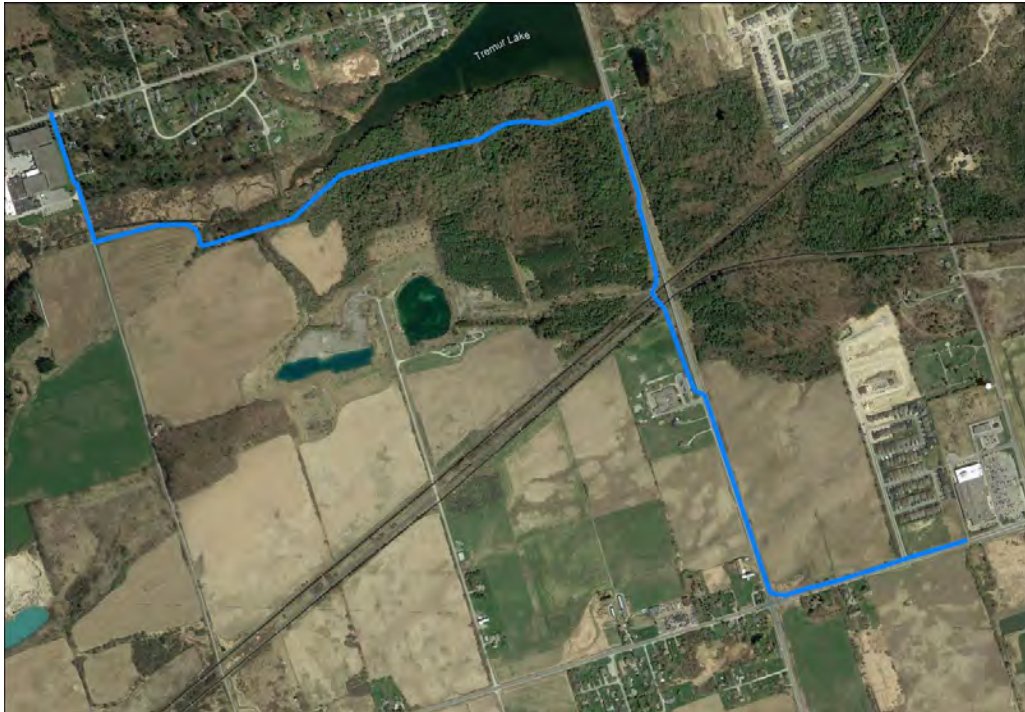
A Class Environmental Assessment (EA) study has been initiated to determine a preferred solution that provides improved water services to the northwest of Trenton. Options for consideration include an additional transmission main, from a connection point on Highway 2, near Walmart, to Tate Road (see map). This option may require additional valve stations to achieve required pressures at the northwest boundary.
